## CERTIFICATE OF THOROUGH EXAMINATION

| Date of Through Examination: 28/07/2026 | Date of Report: 28/07/2026 | Report Number: RAS-U-2607301478 |

| <b>Lorry Loader Crane, Telescopic Boom, Diesel powered, Hydraulic Operated</b> | | | |
| <u>Name and address of employer for whom the thorough examination was made:</u><br><b>Hyundai E&amp;C Company</b> | <u>Crane Model Number:</u> KS2605<br><u>Crane Serial Number:</u> S2C0059<br><u>Crane Manufacturer:</u> KANGLIM<br><u>Year of Manufacture:</u> 2015<br><u>Hook Serial Number:</u> H01 | | <u>Crane Capacity:</u> 10 Ton |

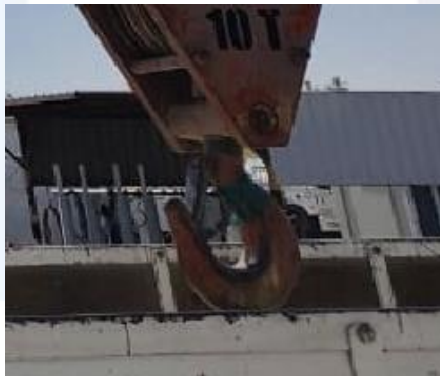
Visual & MPI CARRIED OUT FOR THE ABOVE DESCRIPTION AND FOUND FREE OF SURFACE DEFECTS AT THE TIME OF INSPECTION

Identification of any part found to have a defect and a description of the defect: **NONE**
