## NDT Inspection Report

C/N: RAS-240150052

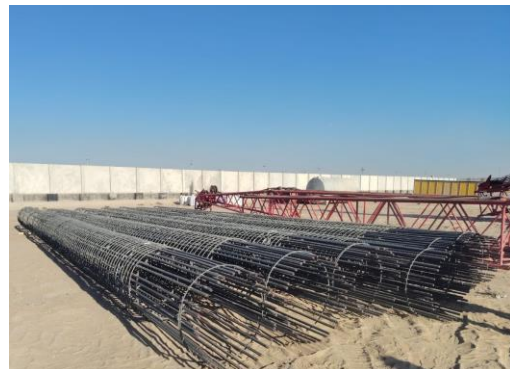
<b>Certificate No:</b> RAS-C-240150052		<b>Date:</b> 2025/11/01	
<b>Customer:</b> Janawa Engineering Company		<b>Due Date:</b> 2026/05/31	
<b>Location:</b> Iraq- Basra			
<b>Name and Address of Owner</b> AL-Yamama Yard		<b>Type &amp; Description</b> 2 lifting Ring at upper & lower ends for Pile Cage Construction	
<b>Manufacture:</b> Janawa <b>Serial Number:</b> 01,02,03,04,05,06,07,08,09,10 <b>Dimension(L×Dia):</b> (16.10×0.85) m <b>Quantity:</b> 10

<b>Status:</b> VISUAL AND MAGNETI PARTICLE INSPECTION (MPI) HAD BEEN DONE ON AND FOUND SATISFACTORY <b>VISUALY:</b> SURFACE INSPECTION OF WELDING.... (ACCEPTED) <b>M.P.I:</b> FREE FROM SURFACE CRACKS OR OTHER DISCONTINUITIES OF INSPECTION... (ACCEPTED)			
<b>Inspection Method</b> 1 - NDT (MPI Test) & Visual Test		<b>Final Results</b> <b>PASSED</b>	
<b>Tools Details</b>			
<b>Description</b>	<b>S/N</b>	<b>Description</b>	<b>S/N</b>
Load Cell	30682/25532	Measuring Tape	N/A

Digital Caliper	4000576010
<b>NDT DETAILS</b>			
<b>Equipment Type:</b> YOKE S/N: A12.512		<b>Standard:</b> ASTM E709	<b>Method:</b> WET
<b>Procedure:</b> RAS-T-21090008		<b>Indicator:</b> MAG INK	
<b>Test Result</b>			
All the above mentioned Points has been tested and found without Crack in Welding And without any Failure so this item <b>SAFE TO USE.</b>			
<b>Name &amp; Qualifications of person making this report:</b> Ahmed Yahya
