## CERTIFICATE OF THOROUGH EXAMINATION

| Description and identification of the equipment:<br><br><b>SPREADER BEAM</b> | <b>TARE WEIGHT:</b> 450 KG<br><b>OVERALL DIM:</b> (3 - 5.4) M (L) X 0.2 M (W) X 0.30 M (H)<br><b>PADEYES THICKNESS:</b> 24 MM<br><b>PADEYES HOLE:</b> 50 MM<br><b>Manufacture:</b><br>AL-MAULA<br><b>SWL:</b><br>30 Ton |

## THROUGH VISUAL & MAGNETIC PARTICLE INSPECTION REPORT

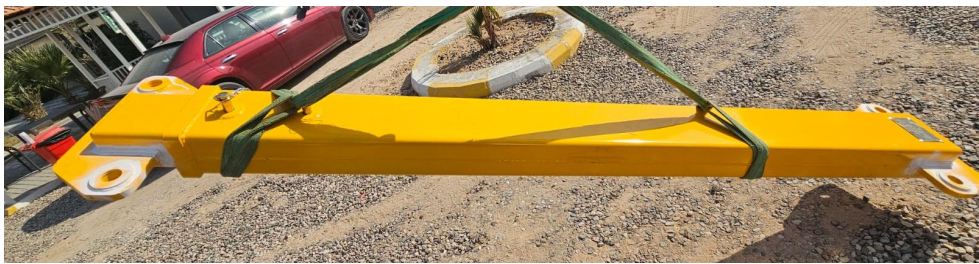
| <b>VISUAL AND MAGNETIC PARTICLE INSPECTION (M.P.I) HAD BEEN DONE ON WELD, FORGN &amp; CRITICAL AREAS FOR THE ABOVE DESCRIPTION</b> | | | |
| <b>VISUALLY: SURFACE INSPECTION OF WELDING.... (ACCEPTED)</b><br><b>M.P.I: FREE FROM SURFACE CRACKS OR ANY OTHER DISCONTINUITIES AT TIME OF INSPECTION...(ACCEPTED)</b> | | | |
