## CERTIFICATE OF THOROUGH EXAMINATION

| Description and identification of the equipment:<br><br>SPREADER BEAM | <b>OVERALL DIM:</b> 350 CM (L) X 20 CM (W) X 50 CM (H)<br><b>PADEYES DIM:</b> 200MM (L) X 110MM (W) X 23MM (TH)<br><b>PADEYES HOLE:</b> 5.1 CM<br><b>Manufacture:</b><br>VELATH<br>ENGINEERING<br><b>SWL:</b><br>21 Ton |

## THROUGH VISUAL & MAGNETIC PARTICLE INSPECTION REPORT

| <b>Name and Address of Owner</b><br>RATAWI | | <b>Type</b><br>SPREADER BEAM WELDING AND STRESS POINTS | |

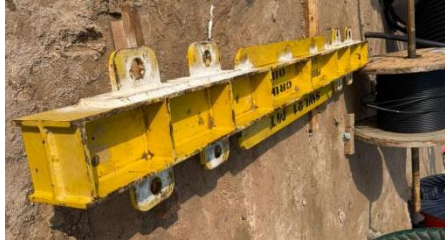
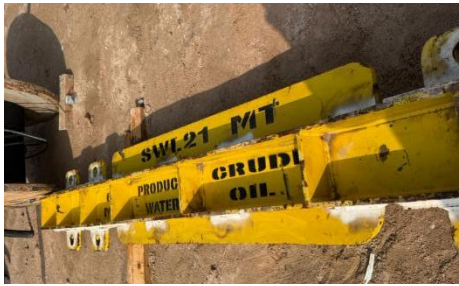
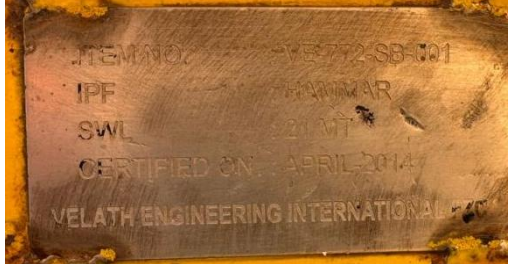
| <p>VISUAL AND MAGNETIC PRATICLE INSPECTION (M.P.I) HAD BEEN DONE ON WELD, FORGN &amp; CRITICAL AREAS FOR THE ABOVE DESCRIPTION</p> <p><b>AND FOUND</b></p> <p><b>VISUALLY:</b> SURFACE INSPECTION OF WELDING.... (ACCEPTED)</p> <p><b>M.P.I:</b> FREE FROM SURFACE CRACKS OR ANY OTHER DISCONTINUITIES AT TIME OF INSPECTION...(ACCEPTED)</p> | | | |
