### VISUAL & MAGNETIC PARTICLE INSPECTION REPORT

| <b>Certificate No:</b> RAS-Y-26075015 | | <b>Date:</b> 22/07/2026 | |
| <b>Name and Address of Owner</b><br><b>OM QASER</b> | | <b>Description</b><br><b>Structural Welded Connection</b> | |

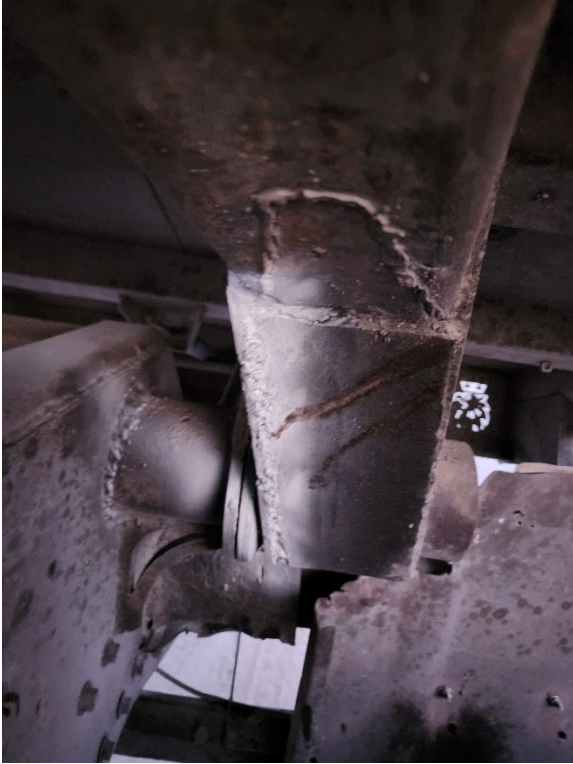
| | | <b>Area of Examination:</b><br>Welded Area on the Frame at the<br>Structural Cross Member Connection | |
| | | <b>Inspection Result:</b><br><br>VISUAL AND MAGNETIC PARTICLE<br>INSPECTION (MPI) HAD BEEN DONE ON<br>WELD & CRITICAL AREAS FOR THE ABOVE<br>DESCRIPTION<br><b>AND FOUND</b><br>VISUALY: SURFACE INSPECTION OF<br>WELDING.... <b>(ACCEPTED)</b><br>M.P.I: FREE FROM SURFACE CRACKS OR<br>OTHER DISCONTINUITIES OF<br>INSPECTION... <b>(ACCEPTED)</b> | |

| This is to certify that the undersigned, a competent inspector, did attend the site for testing to examine and ascertain that this <b>Welded Area on the Frame at the Structural Cross Member Connection</b> is safe for the intended use with the limits specified providing | | | |
