## CERTIFICATE OF THOROUGH EXAMINATION

| Description and identification of the equipment:<br><br>SPREADER BEAM | <b>TARE WEIGHT:</b> 550 KG<br><b>OVERALL DIM:</b> 3.8 M (L) X 0.18 M (W) X 0.18 M (H)<br><b>PADEYES THICKNESS:</b> 30 MM<br><b>PADEYES HOLE:</b> 45 MM<br><b>Manufacture:</b> EUROPEAN BEAM<br><b>SWL:</b> 11 Ton |

## THROUGH VISUAL & MAGNETIC PARTICLE INSPECTION REPORT

| <b>Name and Address of Owner</b><br><b>TAAM CO. YARD</b> | | <b>Type</b><br><b>SPREADER BEAM WELDING AND STRESS POINTS</b> | |

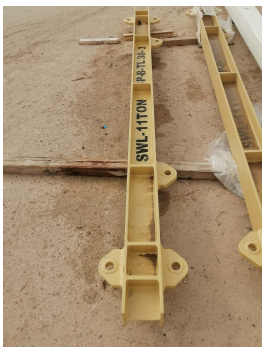
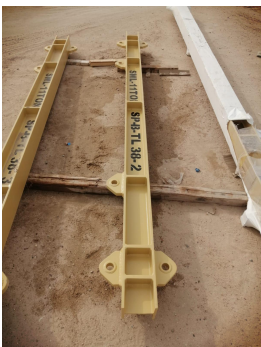
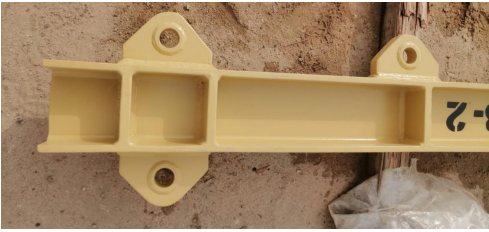
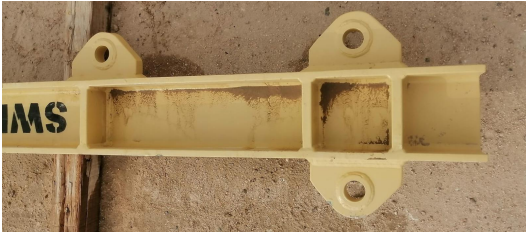
| VISUAL AND MAGNETIC PRATICLE INSPECTION (M.P.I) HAD BEEN DONE ON WELD, FORGN & CRITICAL AREAS FOR THE ABOVE DESCRIPTION | | | |
| VISUALLY: SURFACE INSPECTION OF WELDING.... (ACCEPTED)<br>M.P.I: FREE FROM SURFACE CRACKS OR ANY OTHER DISCONTINUITIES AT TIME OF INSPECTION...(ACCEPTED) | | | |
