## CERTIFICATE OF THOROUGH EXAMINATION

| Date of Through Examination: 28/07/2026 | Date of Report: 28/07/2026 | Report number: <b>RAS-Y-26075023</b> |

| Description and identification of the equipment:<br><br>SPREADER BEAM | <b>TARE WEIGHT:</b> 550 KG<br><b>OVERALL DIM:</b> 3.8 M (L) X 0.18 M (W) X 0.18 M (H)<br><b>PADEYES THICKNESS:</b> 30 MM<br><b>PADEYES HOLE:</b> 45 MM<br><b>Manufacture:</b><br>EUROPEAN BEAM<br><b>SWL:</b><br>22 Ton |

## THROUGH VISUAL & MAGNETIC PARTICLE INSPECTION REPORT

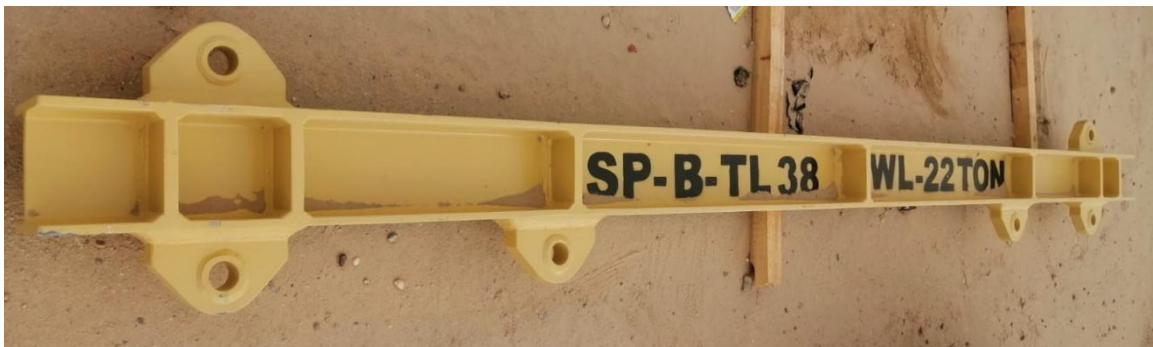
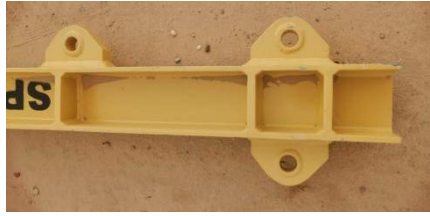
| <b>Results</b> | MPI was carried out on Spreader Beam welding, stress points and they were found free of surface defects at time of inspection. | | | | |

| <p>VISUAL AND MAGNETIC PRATICLE INSPECTION (M.P.I) HAD BEEN DONE ON WELD, FORGN &amp; CRITICAL AREAS FOR THE ABOVE DESCRIPTION</p> <p><b>AND FOUND</b></p> <p><b>VISUALLY:</b> SURFACE INSPECTION OF WELDING.... (ACCEPTED)</p> <p><b>M.P.I:</b> FREE FROM SURFACE CRACKS OR ANY OTHER DISCONTINUITIES AT TIME OF INSPECTION...(ACCEPTED)</p> | | | |
