## CERTIFICATE OF THOROUGH EXAMINATION

| Description and identification of the equipment:<br><br>SPREADER BEAM 2X2 | <b>TARE WEIGHT:</b> 410KG<br><b>MAX GROSS WIGHT:</b> 20410 KG<br><b>BEAM LENGTH :</b> 4.1 m<br><b>PADEYES HOLE:</b> 45 MM<br><b>Manufacture:</b><br>LOCAL<br><b>SWL:</b><br>20 Ton |

## THROUGH VISUAL & MAGNETIC PARTICLE INSPECTION REPORT

| <b>Name and Address of Owner</b><br>IGCC | | <b>Type</b><br>SPREADER BEAM WELDING AND STRESS POINTS | |

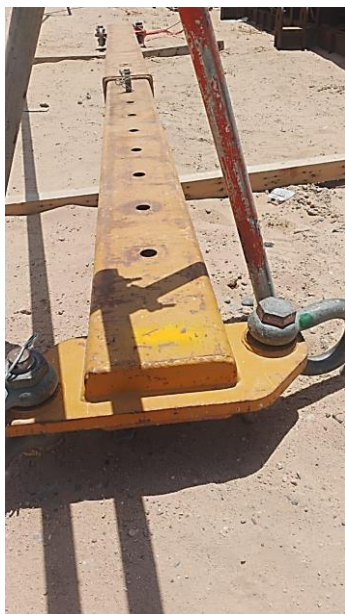
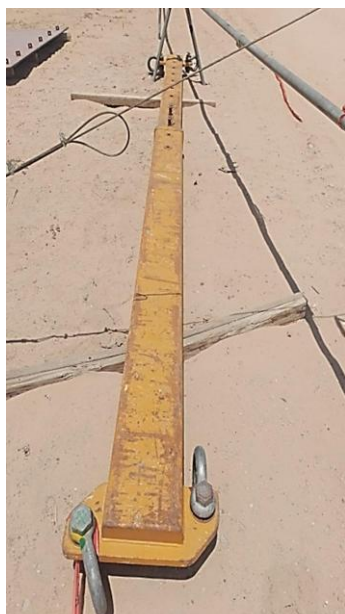
| VISUAL AND MAGNETIC PRATICLE INSPECTION (M.P.I) HAD BEEN DONE ON WELD, FORGN & CRITICAL AREAS FOR THE ABOVE DESCRIPTION | | | |
| VISUALLY: SURFACE INSPECTION OF WELDING.... (ACCEPTED) | | | |
| M.P.I: FREE FROM SURFACE CRACKS OR ANY OTHER DISCONTINUITIES AT TIME OF INSPECTION (ACCEPTED) | | | |
