## CERTIFICATE OF THOROUGH EXAMINATION

| Date of Through Examination: 04/07/2026 | Date of Report: 04/07/2026 | Report number: RAS-MU-260750935 |

| Description and identification of the equipment:<br><br>SPREADER BEAM | <b>OVERALL DIM:</b> 102.5 CM (L) X 18 CM (W) X 0.8 CM (H)<br><b>TOP PADEYES DIM:</b> 90MM (L) X 41MM (TH)<br><b>BOT PADEYES DIM:</b> 65MM (L) X 31MM (TH)<br><b>PADEYES HOLE:</b> 7.4 CM - 5.9 CM<br><b>Manufacture:</b><br>VELATH<br>ENGINEERING<br><b>SWL:</b><br>60 Ton |

## THROUGH VISUAL & MAGNETIC PARTICLE INSPECTION REPORT

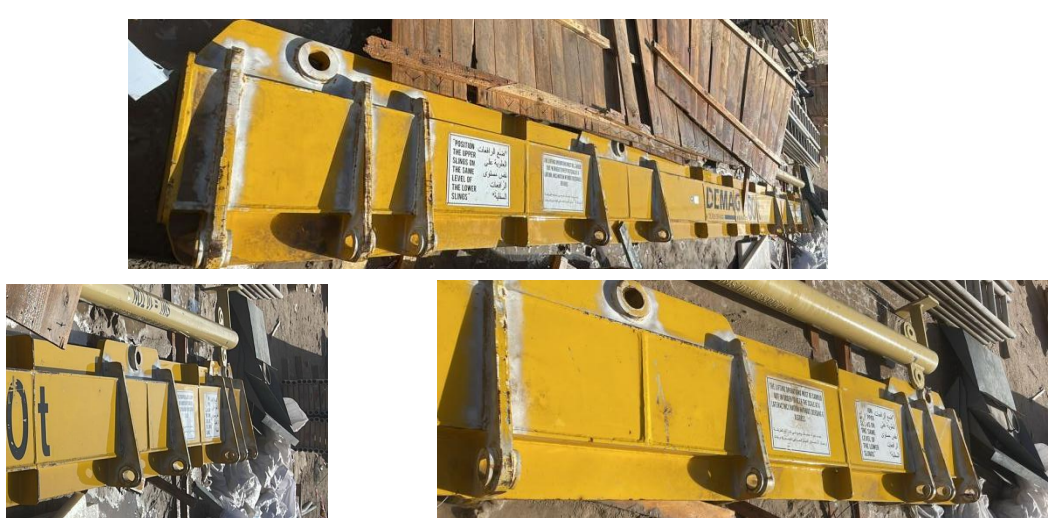
| VISUAL AND MAGNETIC PRATICLE INSPECTION (M.P.I) HAD BEEN DONE ON WELD, FORGN & CRITICAL AREAS FOR THE ABOVE DESCRIPTION | | | |
| VISUALLY: SURFACE INSPECTION OF WELDING.... (ACCEPTED) | | | |
| M.P.I: FREE FROM SURFACE CRACKS OR ANY OTHER DISCONTINUITIES AT TIME OF INSPECTION...(ACCEPTED) | | | |
