## CERTIFICATE OF THOROUGH EXAMINATION

| Date of Through Examination: 23/08/2026 | Date of Report: 23/08/2026 | Report number: RAS-Y-26085015 |

| Description and identification of the equipment:<br><br>SPREADER BEAM | <b>OVERALL DIM:</b> 657 CM (L) X 24 CM (W) X 70 CM (H)<br><b>PADEYES SIZE:</b> 40 mm<br><b>PADEYES HOLE:</b> 5.6 CM<br><b>Manufacture:</b><br>EST<br><b>SWL:</b><br>47.5 Ton |

## THROUGH VISUAL & MAGNETIC PARTICLE INSPECTION REPORT

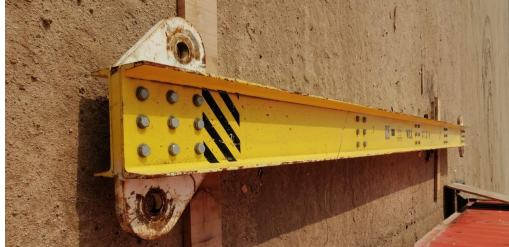
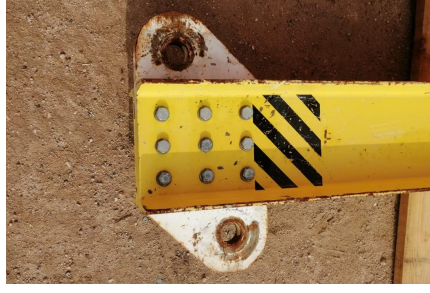
| VISUAL AND MAGNETIC PRATICLE INSPECTION (M.P.I) HAD BEEN DONE ON WELD, FORGN & CRITICAL AREAS FOR THE ABOVE DESCRIPTION | | |
| VISUALLY: SURFACE INSPECTION OF WELDING.... (ACCEPTED)<br>M.P.I: FREE FROM SURFACE CRACKS OR ANY OTHER DISCONTINUITIES AT TIME OF INSPECTION...(ACCEPTED) | | |
