### VISUAL & MAGNETIC PARTICLE INSPECTION REPORT

| <b>Certificate No:</b> RAS-Y-260650221 | | <b>Date:</b> 03/06/2026 | |
| <b>Name and Address of Owner</b><br><b>OM-QASR</b> | | <b>Description</b><br><b>Examination of Welded Joints</b> | |
| | | <b>Area of Examination:</b><br>Twenty-Five (25) Welded Joints<br>local Structural Steel Located on<br>Frame Connections. | |

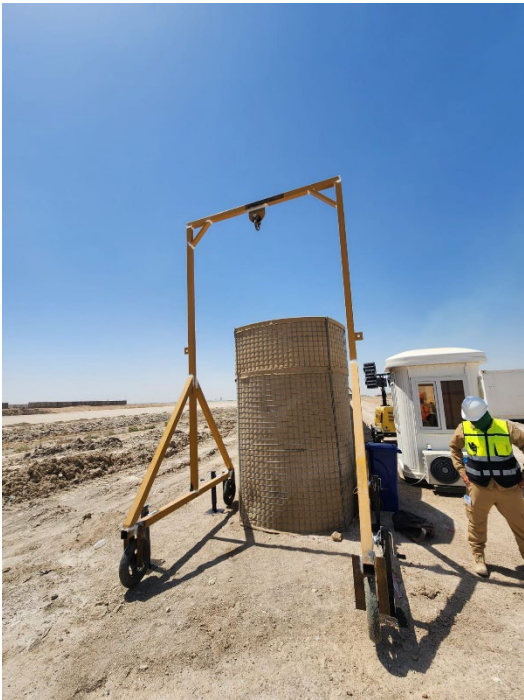
| | | <b>Inspection Result:</b><br><br>VISUAL AND MAGNETIC PARTICLE<br>INSPECTION (MPI) HAD BEEN DONE ON<br>WELD & CRITICAL AREAS FOR THE ABOVE<br>DESCRIPTION<br><b>AND FOUND</b><br>VISUALY: SURFACE INSPECTION OF<br>WELDING.... <b>(ACCEPTED)</b><br>M.P.I: FREE FROM SURFACE CRACKS OR<br>OTHER DISCONTINUITIES OF<br>INSPECTION... <b>(ACCEPTED)</b> | |
