## CERTIFICATE OF THOROUGH EXAMINATION

| Date of Thorough Examination: 21/07/2026 | Date of Report: 21/07/2026 | Report number: <b>RAS-Y-26075013</b> |

| Description and identification of the equipment:<br><br>Steel Tubular Multi-Point<br>Spreader Beam with<br>Welded Lifting Lugs | <b>TARE WEIGHT:</b> 250 KG<br><b>MODEL:</b> MSB-5.0-10T<br><b>SERIAL NO.:</b> MSB2505001<br><b>OVERALL LENGTH:</b> 5.0 m<br><b>SIZE (Ø / SECTION):</b> 0.21 m | <b>Manufacture:</b><br>MODULIFT<br><b>SWL:</b><br>10 Ton | |

## THROUGH VISUAL & MAGNETIC PARTICLE INSPECTION REPORT

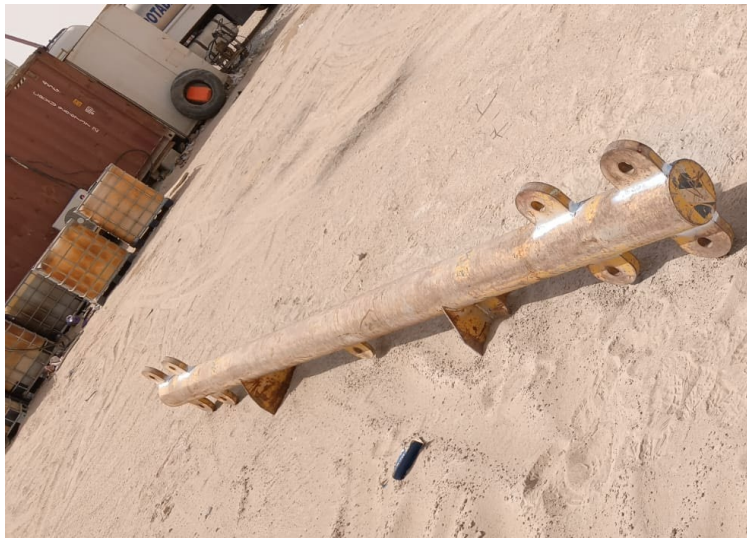
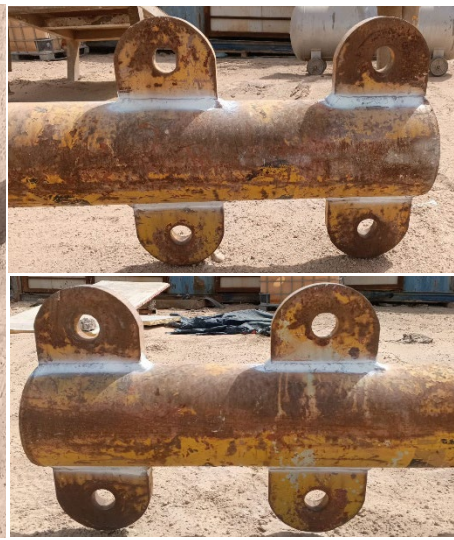
| VISUAL AND MAGNETIC PRATICLE INSPECTION (M.P.I) HAD BEEN DONE ON WELD, FORGN & CRITICAL AREAS FOR THE ABOVE DESCRIPTION | | | |
| VISUALLY: SURFACE INSPECTION OF WELDING.... (ACCEPTED)<br>M.P.I: FREE FROM SURFACE CRACKS OR ANY OTHER DISCONTINUITIES AT TIME OF INSPECTION...(ACCEPTED) | | | |
