## CERTIFICATE OF THOROUGH EXAMINATION

| Date of Thorough Examination: 14/08/2026 | Date of Report: 14/08/2026 | Report number: <b>RAS-Y-26085010</b> |

| Description and identification of the equipment:<br><br><b>SPREADER BEAM</b> | <b>TARE WEIGHT:</b> 342 KG<br><b>OVERALL DIM:</b> 3.48 m (L) X 0.21m (W) X 0.66 m (H)<br><b>PAD EYE DIMENSION:</b><br><b>Pin hole:</b> 65 mm <b>Thickness:</b> 60 mm<br><b>Length:</b> 300 mm <b>Height:</b> 200 mm<br><b>Span central distance between pad eyes centers:</b> 3.2m<br><b>Manufacture:</b><br>Movin Tech<br><b>SWL:</b><br>45 Ton |

### EXAMINED IN ACCORDING TO BS EN 13155:2003 + A2: 2009

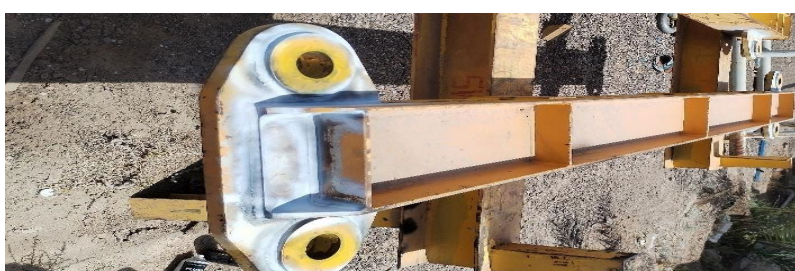
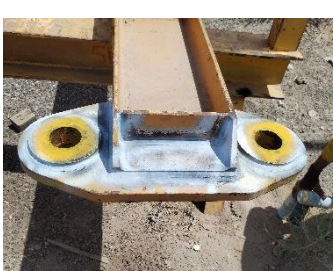
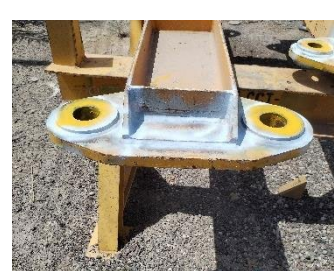
| VISUAL AND MAGNETIC PRATICLE INSPECTION (M.P.I) HAD BEEN DONE ON WELD, FORGN & CRITICAL AREAS FOR THE ABOVE DESCRIPTION | | | |
| VISUALLY: SURFACE INSPECTION OF WELDING.... (ACCEPTED)<br>M.P.I: FREE FROM SURFACE CRACKS OR ANY OTHER DISCONTINUITIES AT TIME OF INSPECTION. (ACCEPTED) | | | |
